# HAZARD DIVISION 1.2 TESTING IN A MINIATURE MAGAZINE

6. AUTHOR(S)  Michael M. Swisdak, Jr.				
7. PERFORMING ORGANIZATIONS NAME(S) AND ADDRESS(ES)  Indian Head Division Naval Surface Warfare Center Indian Head, MD 20640-5035			8. PERFORMING ORGANIZATION REPORT NUMBER  IHTR 2158

Subj: THERMAL ANALYSIS OF THE RED RIVER IGLOO FIRE AND CHINA LAKE MINI-MAGAZINE FIRE TEST

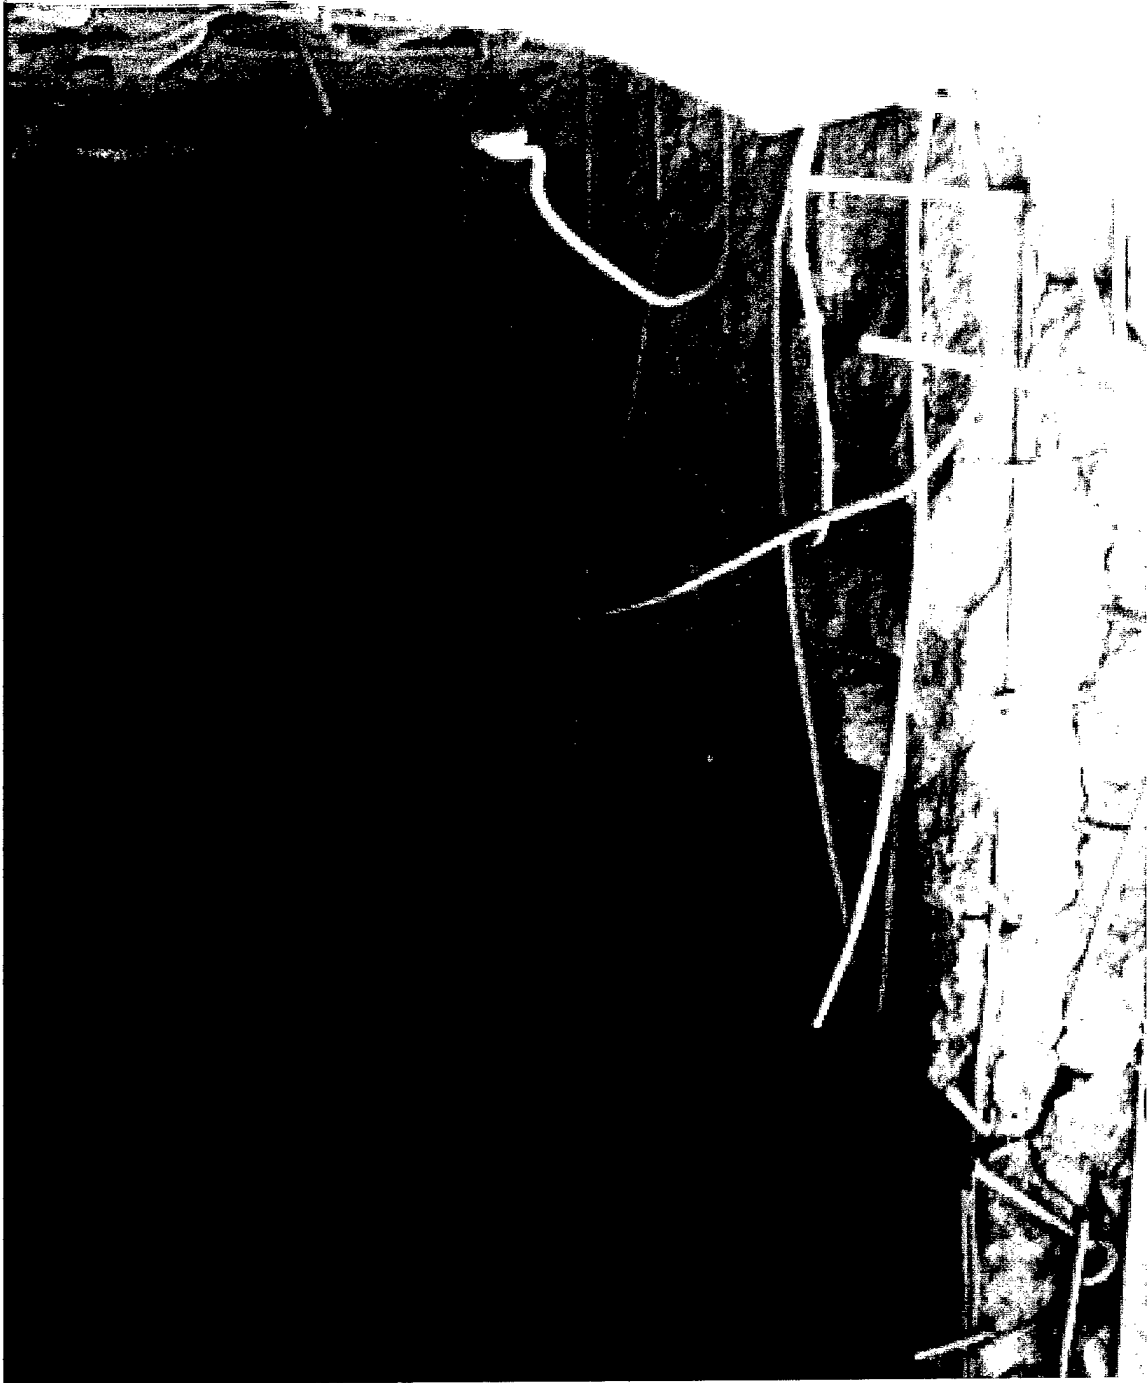
***Figure 4-1. Damage to Inside of Structure***

The external walls of the magazine (sides and rear) that held the sand around the storage compartment were undamaged, except for a very small hairline crack in the back. The inside surface of the chamber walls and ceiling were highly damaged—apparently from the thermal environment. The concrete surface appeared very porous and flaky, and in many places it showed evidence of extensive spalling to the depth of the first layer of rebar. At one location near the floor, the spall extended beyond the second layer of rebar. The bottom of the compartment was covered with spall debris, concrete powder, fragments, and intact rounds. The floor itself was completely destroyed. The roof had spall damage extending to the depth of the first layer of the rebar making it unsafe to work inside the structure. The outside surface of the front wall that was downwind from the opening for the front door was heavily spalled, whereas there was no spall damage on the outside wall surface upwind of the door opening. The same comment is true for the underside surface of the fragmentation canopy. A portion of the front wall of the storage compartment with dimensions equivalent to the width of the vent and the height of the doorframe was destroyed. However, the rubble remained in the barricaded area in front of the magazine. Figure 4-1 is a post-test photograph of the interior of the structure showing some of the damage to the floor, ceiling, and side wall.

Although it was severely damaged, the structure survived the event. Thermocouples indicated that it was exposed to temperatures of over 700 °C during the first 22 minutes of the test. The majority of the observed damage was attributable to thermal effects rather than to blast or fragment attack. The fact that the concrete had cured for only 24 days instead of the required 28 days prior to the test did not significantly alter the response of the structure. Because the structure was severely weakened, it was unsafe to work inside it. It was also decided that it was uneconomical to try to repair it. Rather, the structure was razed at the end of the test.
